# TECHNICAL ASPECTS OF TECHNOLOGY TRANSFER DURING THE LORAL FAILURE INVESTIGATION

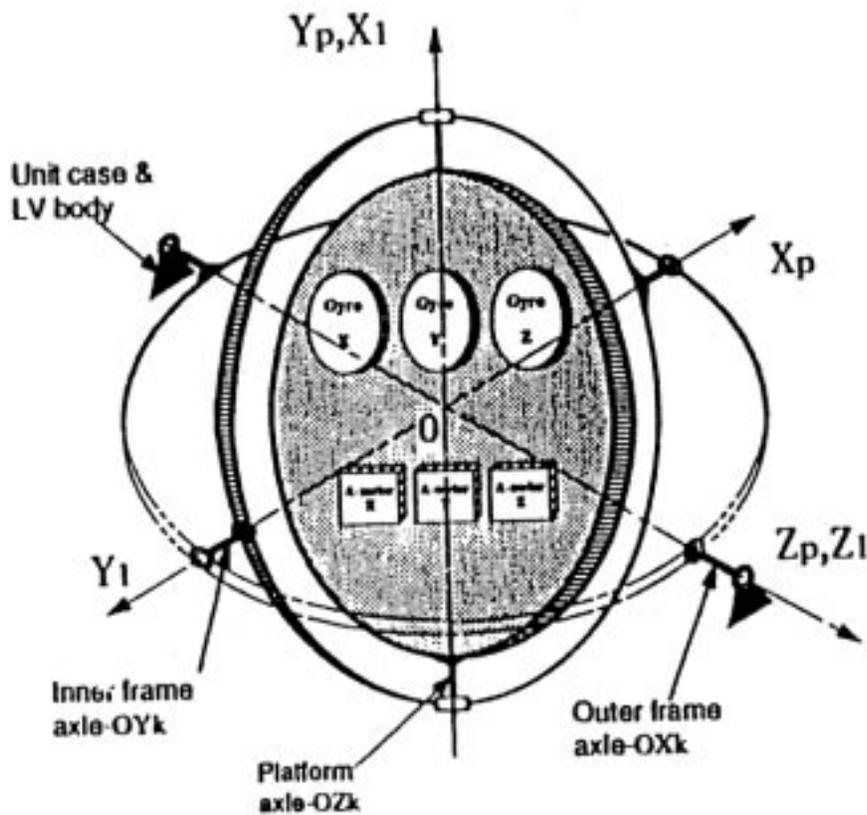
IMU of LM-3

As presented by the PRC participants, the older inertial measurement unit used in the Long March 3 weighed 140 kilograms, and measured 500 x 600 x 800 mm. It had three gimbal axes and three single-axis gyroscopes on its inertial platform. It was also said to have a high degree of redundancy to preclude single point failures. The newer Long March 3B inertial measurement unit was presented as having a weight of 48 kilograms, and dimensions of 300 x 300 x 400 mm. It had four gimbal axes with only two (two-axis) gyroscopes on its inertial platform.

An artist's rendition of the difference in design between the inertial measurement unit used on the Long March 3 as compared to that used on the Long March 3A, 3B, and 3C rockets. The two illustrations are not shown to the same scale; the Long March 3 inertial measurement unit is much larger, and weighs nearly three times more.

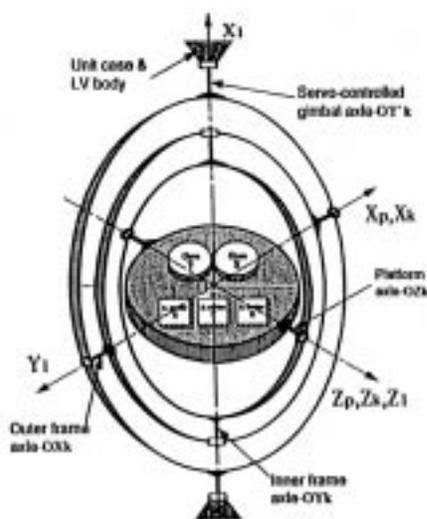
IMU of LM-3A/3B/3C

The fourth gimbal axis in the newer Long March 3B unit is associated with the addition of a follow-up frame to the platform mechanism. The follow-up frame precludes the occurrence of gimbal lock. This can take place in inertial platform assem-
